# Fi2000<sub>®</sub>

KAWASAKI VN1500 CLASSIC 05-08

Instruction Manual > 92-0940T Page 3 of 3
-------------------------------------------

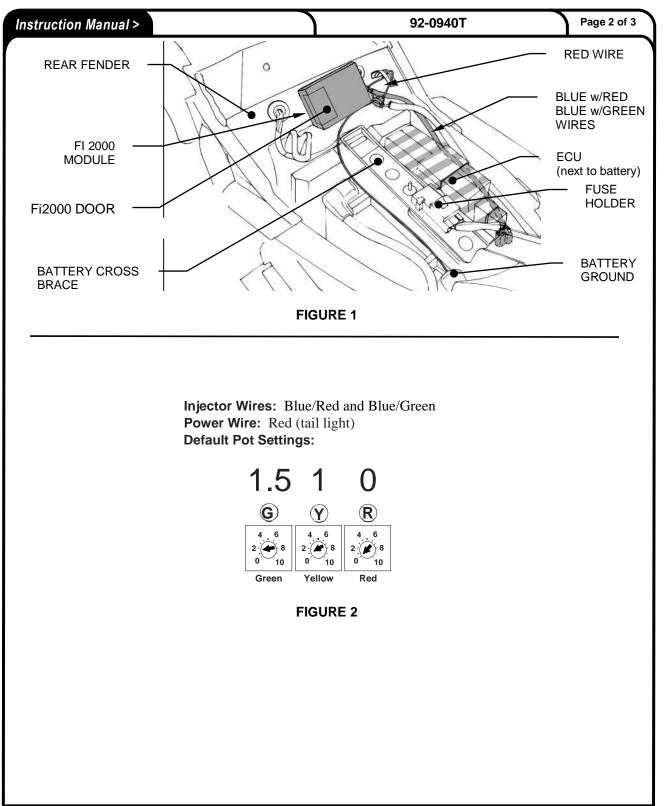
<ol> <li>Remove the battery cross brace by unscrewing the phillips head screw and unattaching the fuse box from the brace. See figure 1.</li> <li>Locate the ECU next to the battery and lift it straight up and out to locate the BLUE w/RED stripe wire and the BLUE w/GREEN stripe wire on the harness going to the ECU. Attach a t-tap connector to each of these wires about an inch from the connector on the ECU. See figure 1</li> <li>Plug the Fi2000 module's BLUE w/RED stripe and BLUE w/GREEN stripe wires to the corresponding ECU wires with the t-tap connectors and replace the ECU to its original location. Make sure to route the wires so they do not get pinched by the seat when installed. See figure 1. Note: Make sure not to attach the t-tap connectors closer than 1" to the stock ECU connector.</li> <li>Reinstall the battery cross brace, phillips head screw and fuse holder.</li> <li>Locate the RED wire at the tail light harness plug (the wire harness goes through the grommet in the rear fender). and attach a t-tap connector there. See figure 1.</li> <li>Attach the Fi2000 module's RED wire to the t-tap connector installed in step 6 and the BLACK wire to the negative post of the battery. Make sure to route the wires so they do not get pinched by the seat when installed as shown in figure 1</li> <li>Remove the backing from the Velcro and attach the module on the rear fender between the two grommets as shown in figure 1.</li> <li>Before re-installing the seat, verify your connections. Remove the door from the Fi2000 box to expose the LED's are on steady. If you have no light, either your ground connection (BLACK wire) is not solid or, (more likely) your RED wire connection is incorrect. You have either tapped on the wire by as rot made contact. (2) After achieving a steady light from all three LED's are still on after start up, your BLUE w/RED stripe wire connection is incorrect; if all three LED's are flashing, your BLUE w/GREEN stripe wire connection is wrong. Again verify correct color a</li></ol>

<ul> <li>wire and the BLUE w/GREEN stripe wire on the harness going to the ECU. Attach a t-tap connector to each of these wires about an inch from the connector on the ECU. See figure 1</li> <li>Plug the Fi2000 module's BLUE w/RED stripe and BLUE w/GREEN stripe wires to the corresponding ECU wires with the t-tap connectors and replace the ECU to its original location. Make sure to route the wires so they do not get pinched by the seat when installed. See figure 1. Note: Make sure not to attach the t-tap connectors closer than 1" to the stock ECU connector.</li> <li>Reinstall the battery cross brace, phillips head screw and fuse holder.</li> <li>Locate the RED wire at the tail light harness plug (the wire harness goes through the grommet in the rear fender). and attach a t-tap connector installed in step 6 and the BLACK wire to the negative post of the battery. Make sure to route the wires so they do not get pinched by the seat when installed as shown in figure 1</li> <li>Remove the backing from the Velcro and attach the module on the rear fender between the two grommets as shown in figure 1.</li> <li>Before re-installing the seat, verify your connections. Remove the door from the Fi2000 box to expose the LED's. Verify the wire connections by (1) turning the ignition on, prior to starting, and see if all three LED's are on steady. If you have no light, either your ground connection (BLACK wire) is not solid or, (more likely) your RED wire connection is incorrect. You have either tapped on the wrong wire or the tap has not made contact. (2) After achieving a steady light from all three LED's are flashing, your BLUE w/GREEN stripe wire connection is incorrect; if all three LED's are flashing, your BLUE w/GREEN stripe wire connection is incorrect; if all three LED's are flashing, your met all the door when finished. Note: Make sure the ignition is turned off before changing any connection.</li> </ul>	2.		wing the phillips head screw and unattachin	g the fuse

<ol> <li>Locate the RED wire at the tail light harness plug (the wire harness goes through the grommet in the rear fender). and attach a t-tap connector there. See figure 1.</li> <li>Attach the Fi2000 module's RED wire to the t-tap connector installed in step 6 and the BLACK wire to the negative post of the battery. Make sure to route the wires so they do not get pinched by the seat when installed as shown in figure 1</li> <li>Remove the backing from the Velcro and attach the module on the rear fender between the two grommets as shown in figure 1.</li> <li>Before re-installing the seat, verify your connections. Remove the door from the Fi2000 box to expose the LED's. Verify the wire connections by (1) turning the ignition on, prior to starting, and see if all three LED's are on steady. If you have no light, either your ground connection (BLACK wire) is not solid or, (more likely) your RED wire connection is incorrect. You have either tapped on the wrong wire or the tap has not made contact. (2) After achieving a steady light from all three LED's are still on after start up, your BLUE w/RED stripe wire connection is incorrect; if all three LED's are flashing, your BLUE w/GREEN stripe wire connection is wrong. Again verify correct color and tap contact. Reattach the door when finished. Note: Make sure the ignition is turned off before changing any connection.</li> </ol>	4.	corresponding ECU wires with the t-tap connectors and replace the ECU to its original location. Make sure to route the wires so they do not get pinched by the seat when installed. See figure 1.

<ul> <li>wire to the negative post of the battery. Make sure to route the wires so they do not get pinched by the seat when installed as shown in figure 1</li> <li>8. Remove the backing from the Velcro and attach the module on the rear fender between the two grommets as shown in figure 1.</li> <li>9. Before re-installing the seat, verify your connections. Remove the door from the Fi2000 box to expose the LED's. Verify the wire connections by (1) turning the ignition on, prior to starting, and see if all three LED's are on steady. If you have no light, either your ground connection (BLACK wire) is not solid or, (more likely) your RED wire connection is incorrect. You have either tapped on the wrong wire or the tap has not made contact. (2) After achieving a steady light from all three LED's are still on after start up, your BLUE w/RED stripe wire connection is incorrect; if all three LED's are flashing, your BLUE w/GREEN stripe wire connection is wrong. Again verify correct color and tap contact. Reattach the door when finished. Note: Make sure the ignition is turned off before changing any connection.</li> </ul>	6.
